**U. S. Department of the Interior**  
Bureau of Land Management

**BLM-Alaska Open File Report 85**  
BLM/AK/ST-02/005-6610-020  
February 2002

## **Adult Salmon Runs and Streamflow Data at a Resistance Board Weir on Beaver Creek, Alaska, 1998-2000**

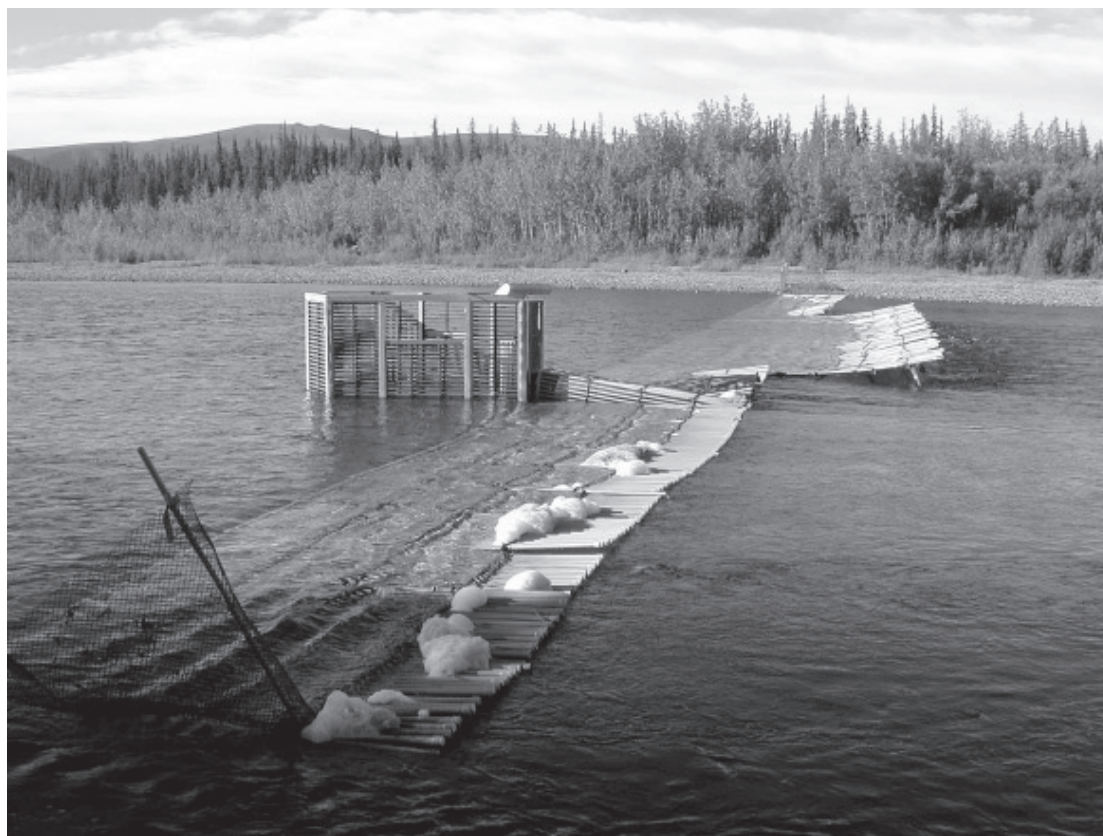
Beaver Creek weir and trap, 2000. BLM photo.

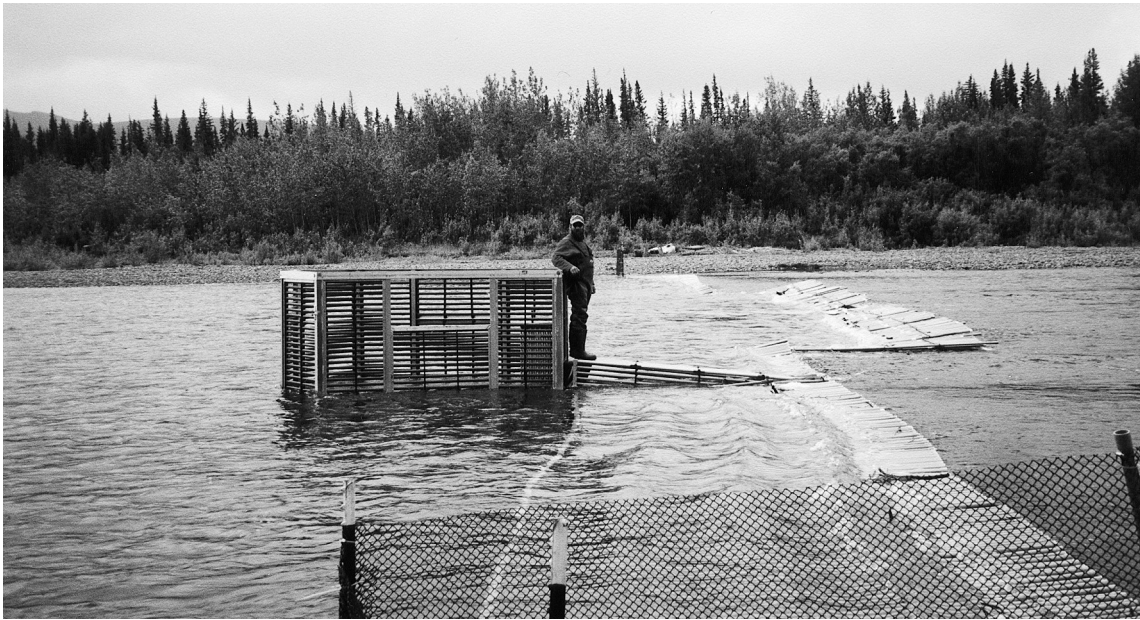
FIGURE 2 Installed weir and trap.

The materials, construction methods, and installation of the weir are generally described by Collin and Kostohrys (1998). In 1999 picket panels were added between the trap and the bank to move the trap out into the stream to maintain adequate depth at low flows. The weir installation is shown in Figure 2.

Although the trap had an upstream door, when we opened this to allow fish to swim out, the fish would often wash back onto the weir. We would then recover and carry the fish upstream to slower water. This process caused extra stress, so we stopped using the door. When possible, we recommend the trap be placed in such a way that fish can swim through the upstream door into water where it would be easy to maintain position in the stream.
